Village of Norridge

Initial Lead Service Line Replacement Plan

REL Project 22-R0901

April 15, 2024

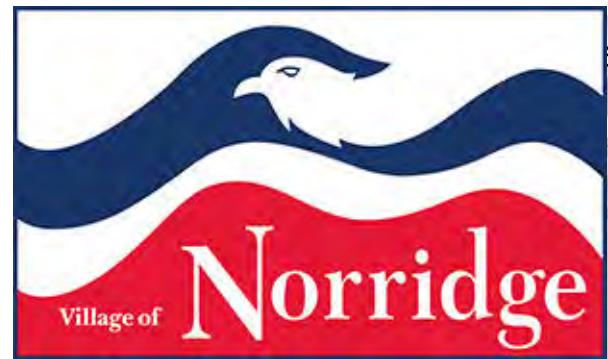
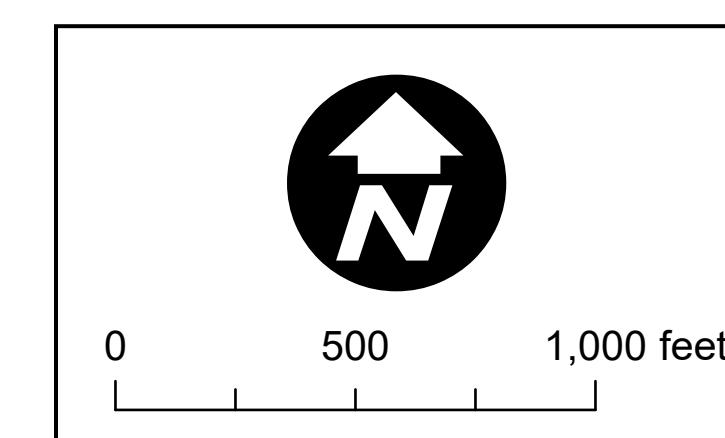
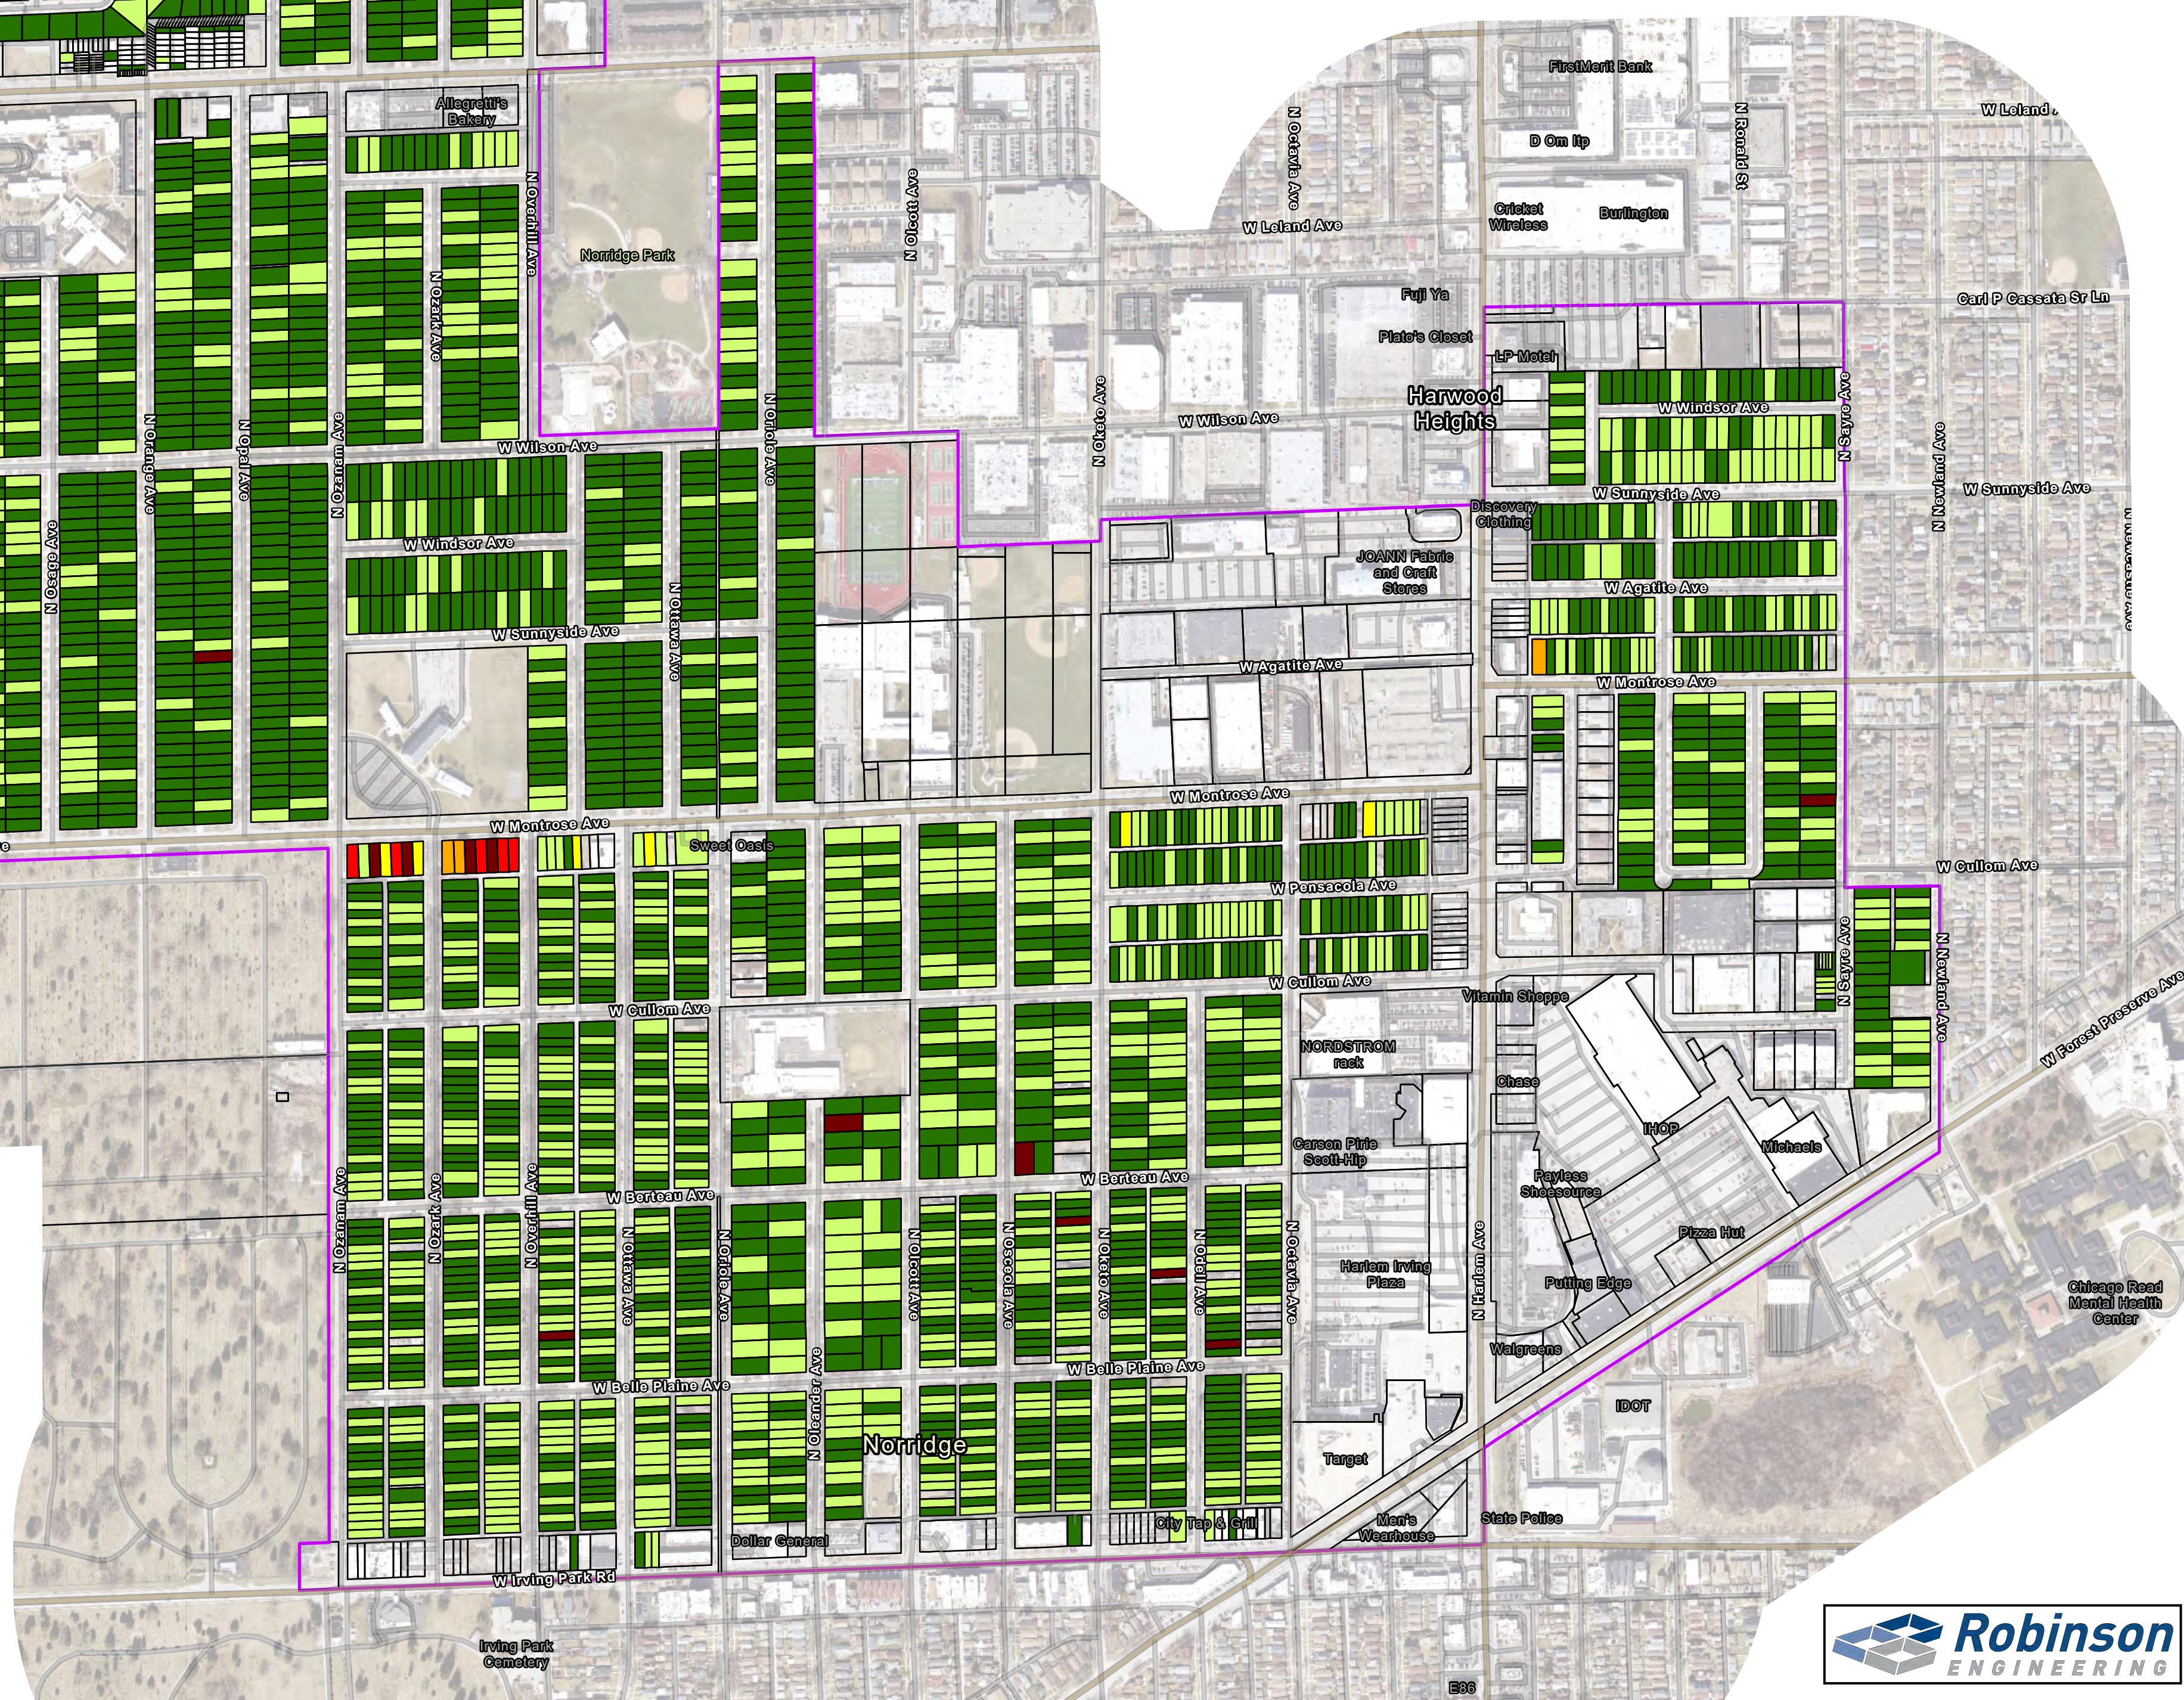
Appendix 3 Building Age Map

VILLAGE OF NORRIDGE LEAD SERVICE PROBABILITY

- **Building Age:** For those buildings constructed after 1988, service lines are assumed to be non-lead on both the public and private sides.
- **Historical Records:** Where available, historical records were used to identify service line material. Historical records could include water meter replacement records, water main replacement records, water main tapping cards, water meter cards, permit records, and documentation from maintenance and repairs.

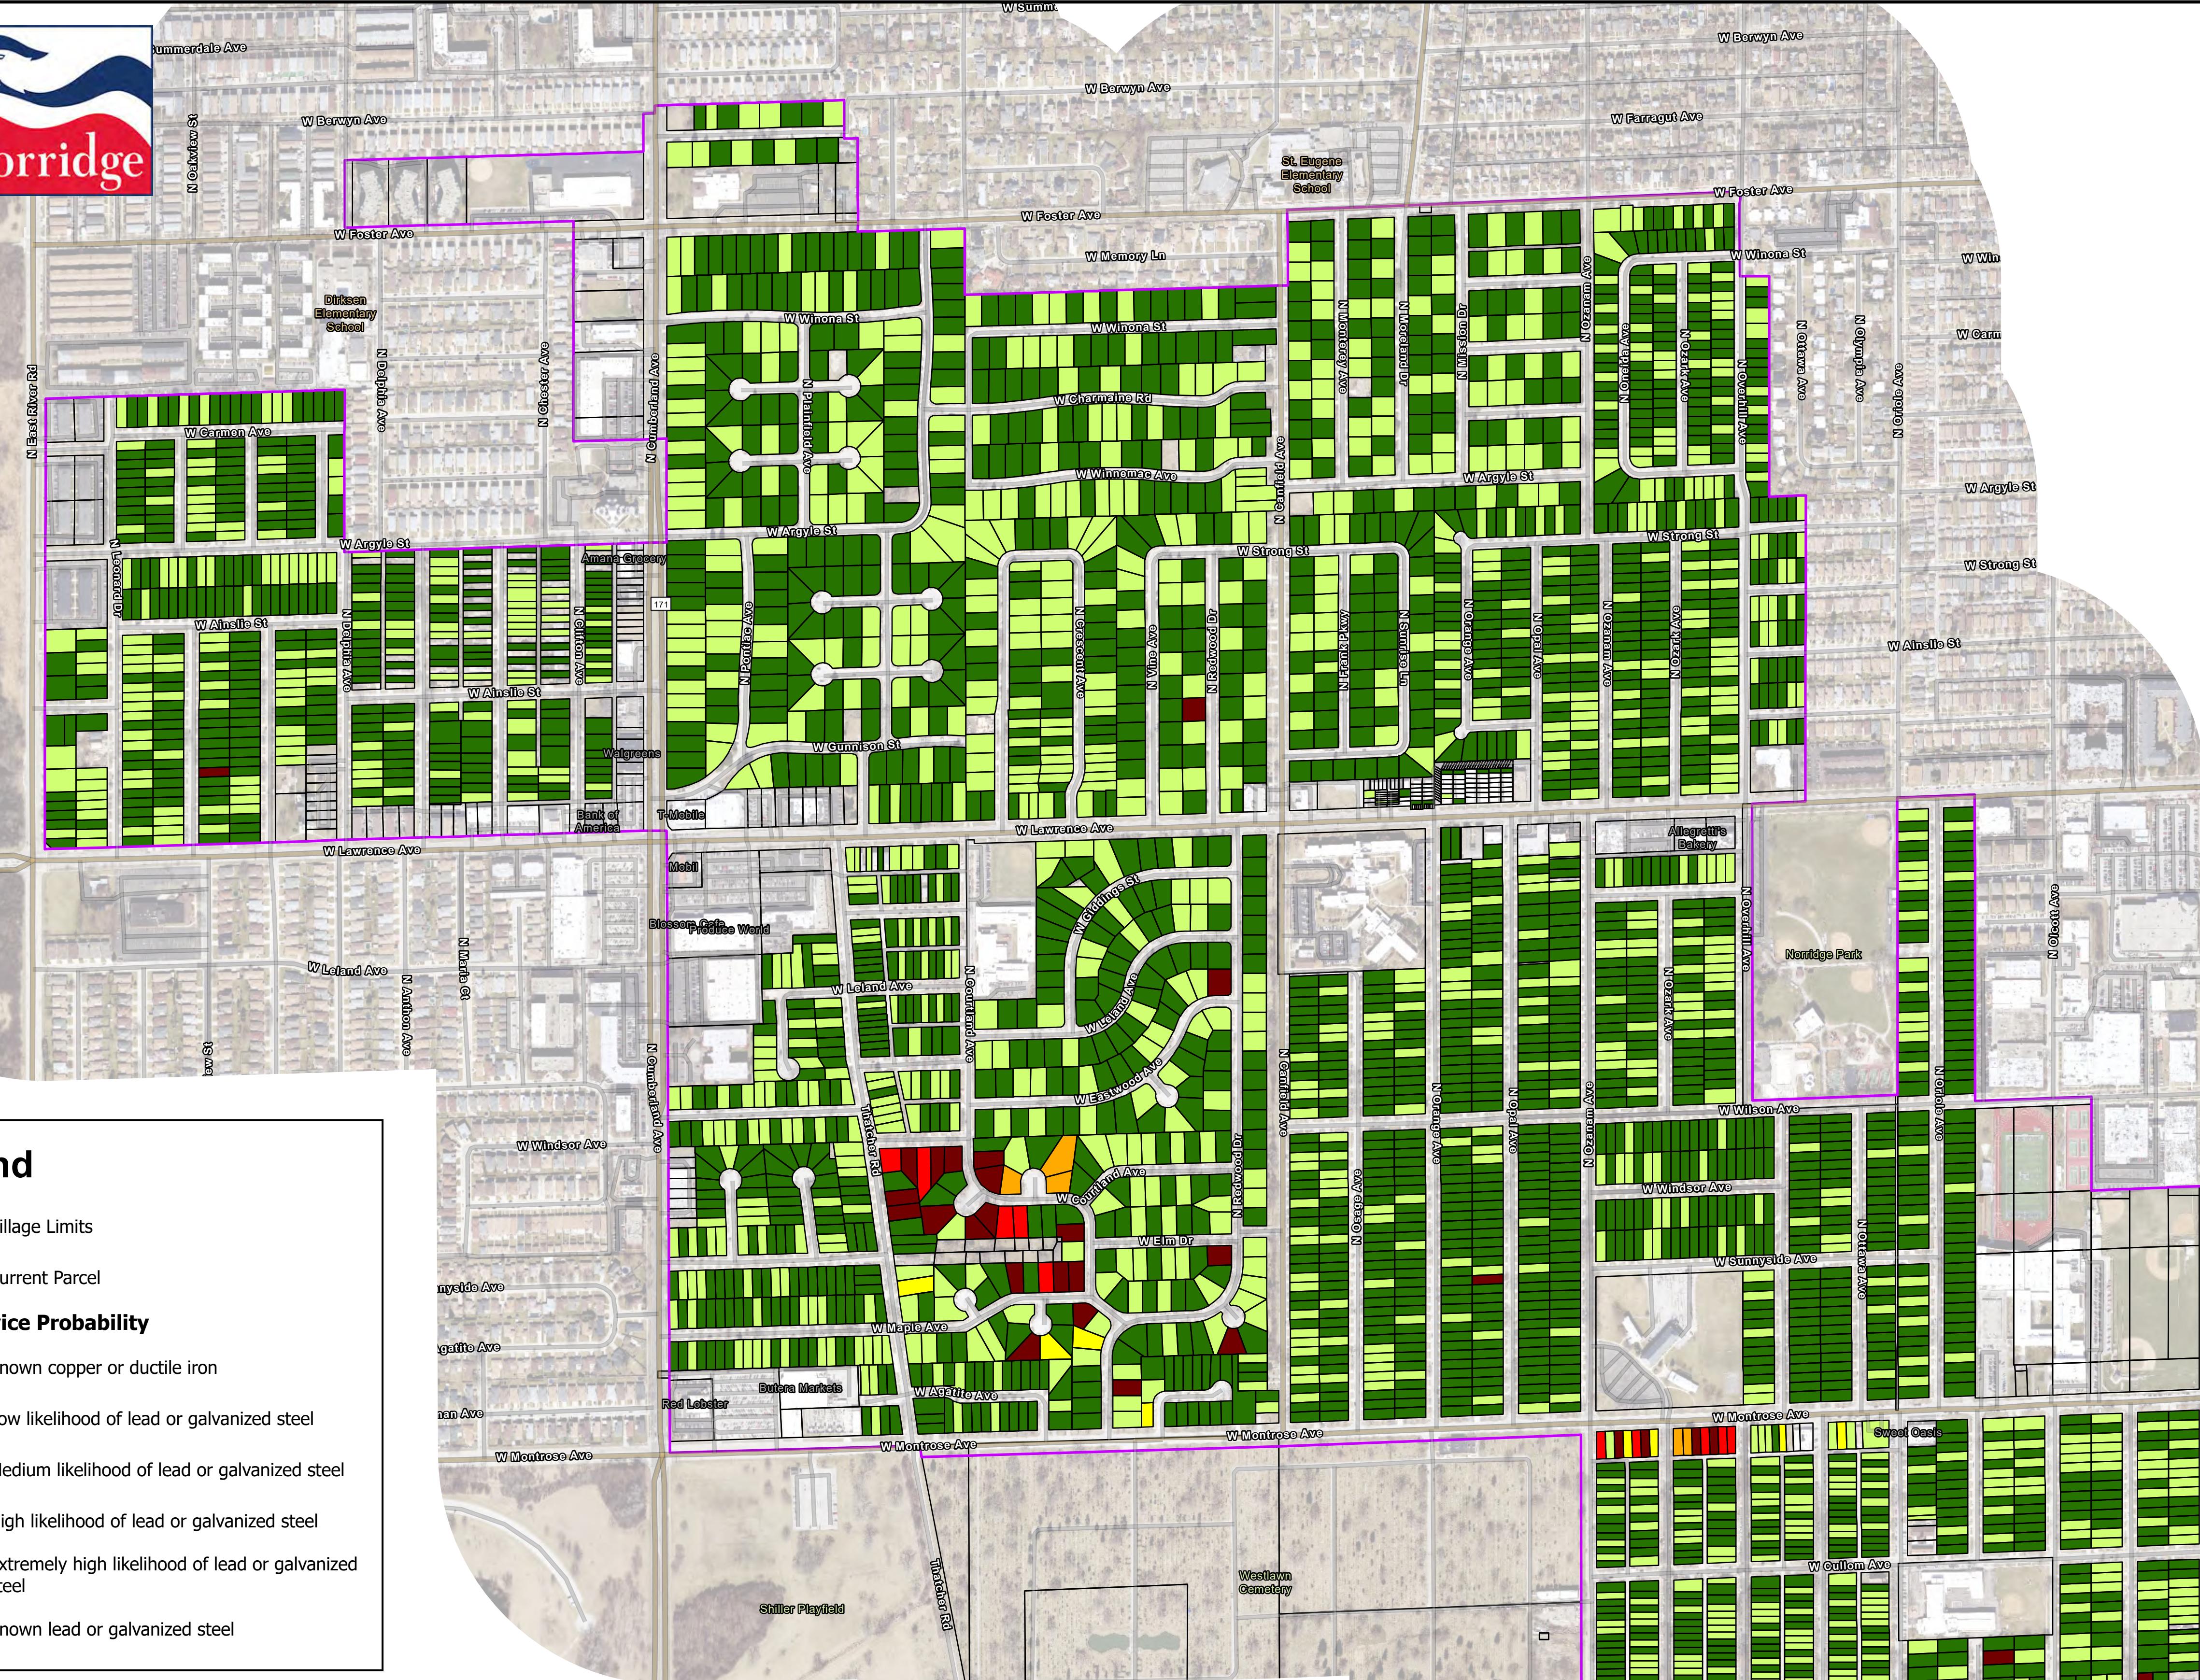
- Village Limits
- Current Parcel
- Lead Service Probability**
 - Known copper or ductile iron
 - Low likelihood of lead or galvanized steel
 - Medium likelihood of lead or galvanized steel
 - High likelihood of lead or galvanized steel
 - Extremely high likelihood of lead or galvanized steel
 - Known lead or galvanized steel

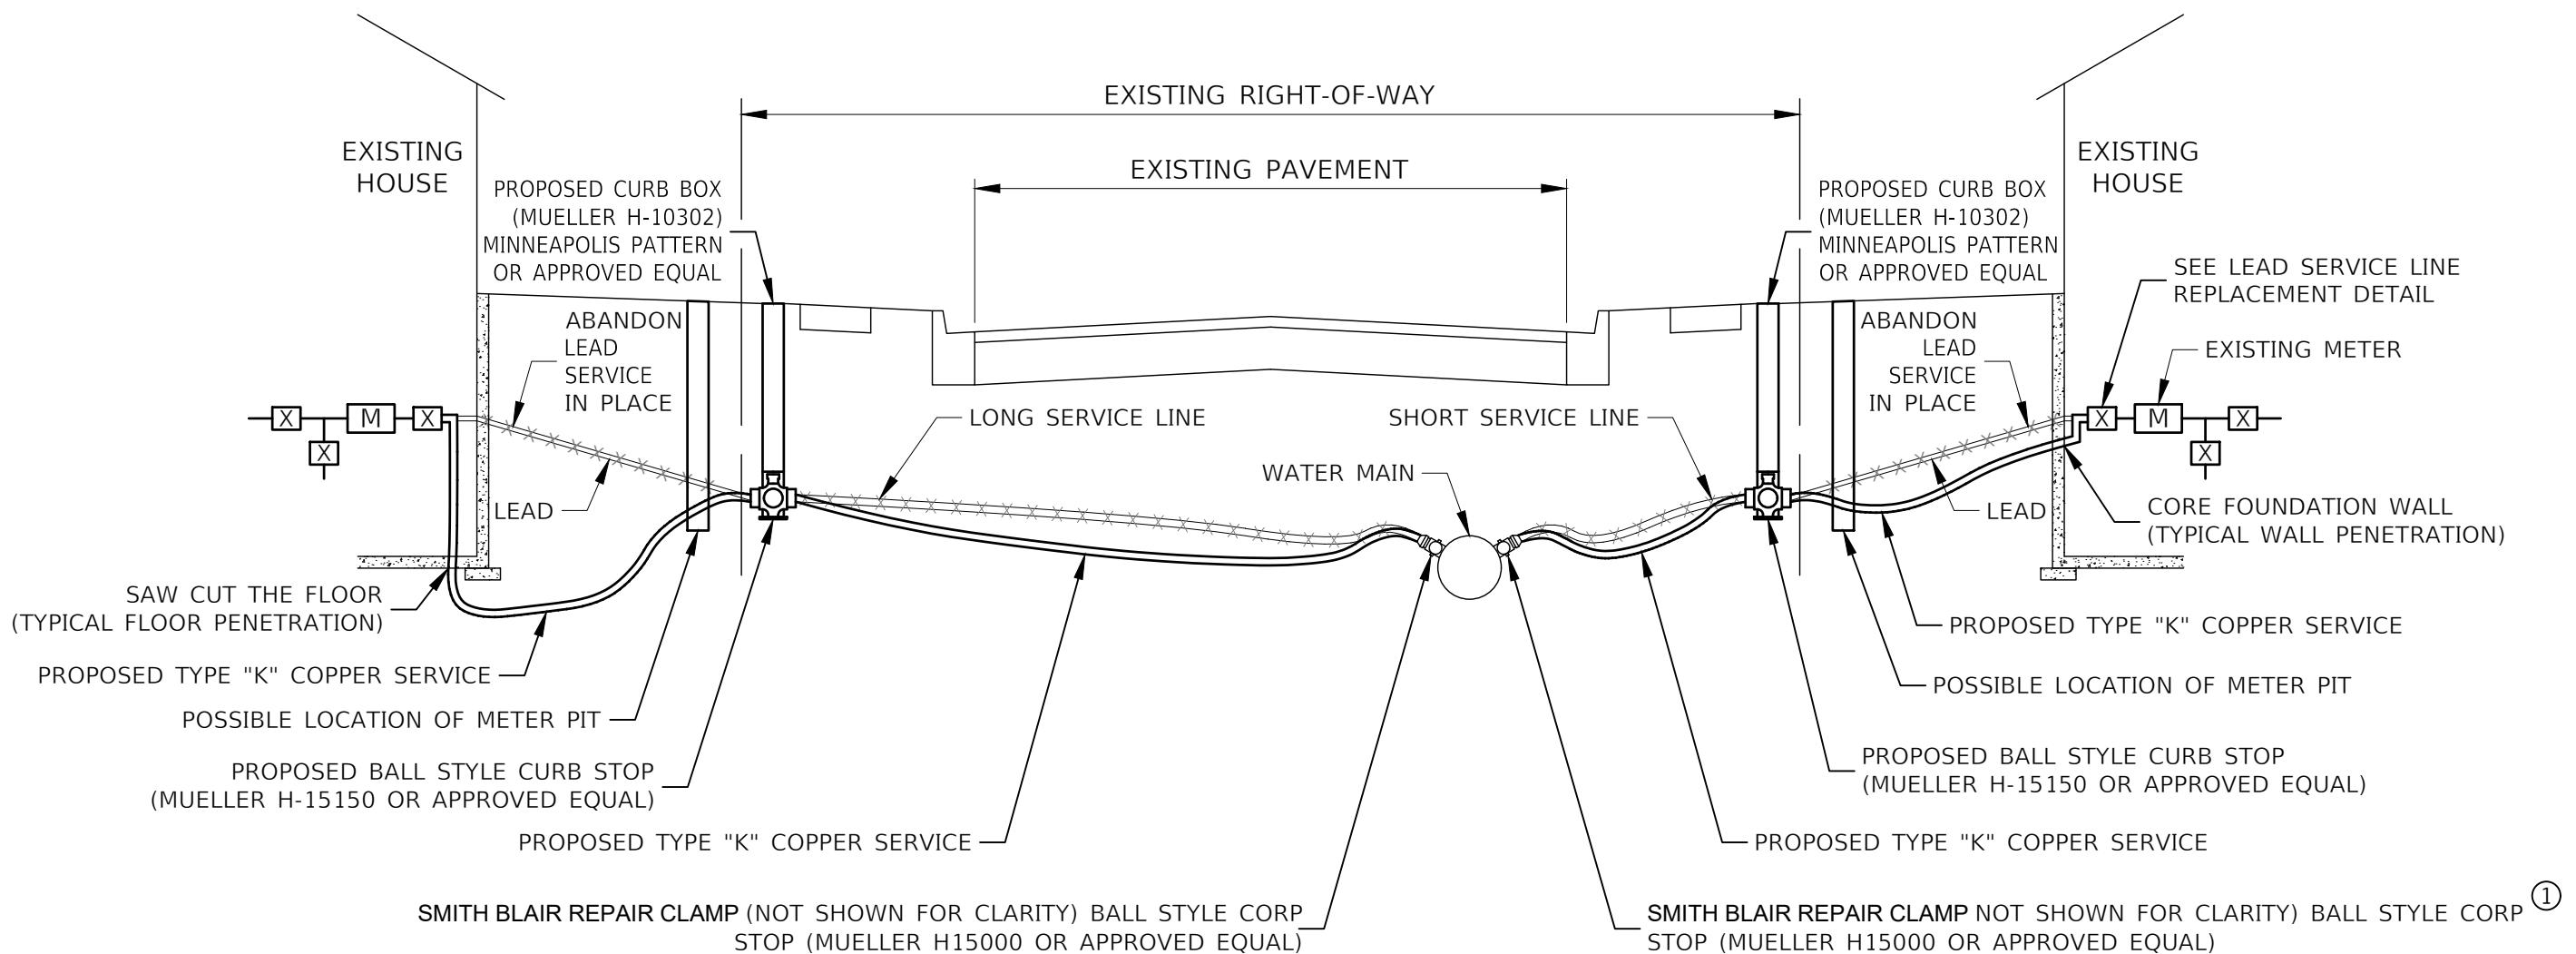
FULL LEAD WATER SERVICE REPLACEMENT
(COPPER)

NOTE:
 (1) SEE SPECIFICATIONS FOR WATER MAIN TAPPING.

The work shall consist of the removal and replacement of lead or galvanized iron water services for buildings within the specified service area. The area will be determined based on prioritization, material, building age, and funding limits, but all will be within the corporate boundaries of the CWS. New copper service lines shall be installed for full and partial lead service line replacement. Full lead service line replacement shall be defined as connecting from the water main to inside the building. Partial service line replacement shall be defined as connecting from the curb box (B-box or buffalo box) to the water main. No lead piping will be left in the water system. Partial replacements will only occur where the existing service is partially lead or galvanized. Cross-sectional replacement details are included in Appendix 5.

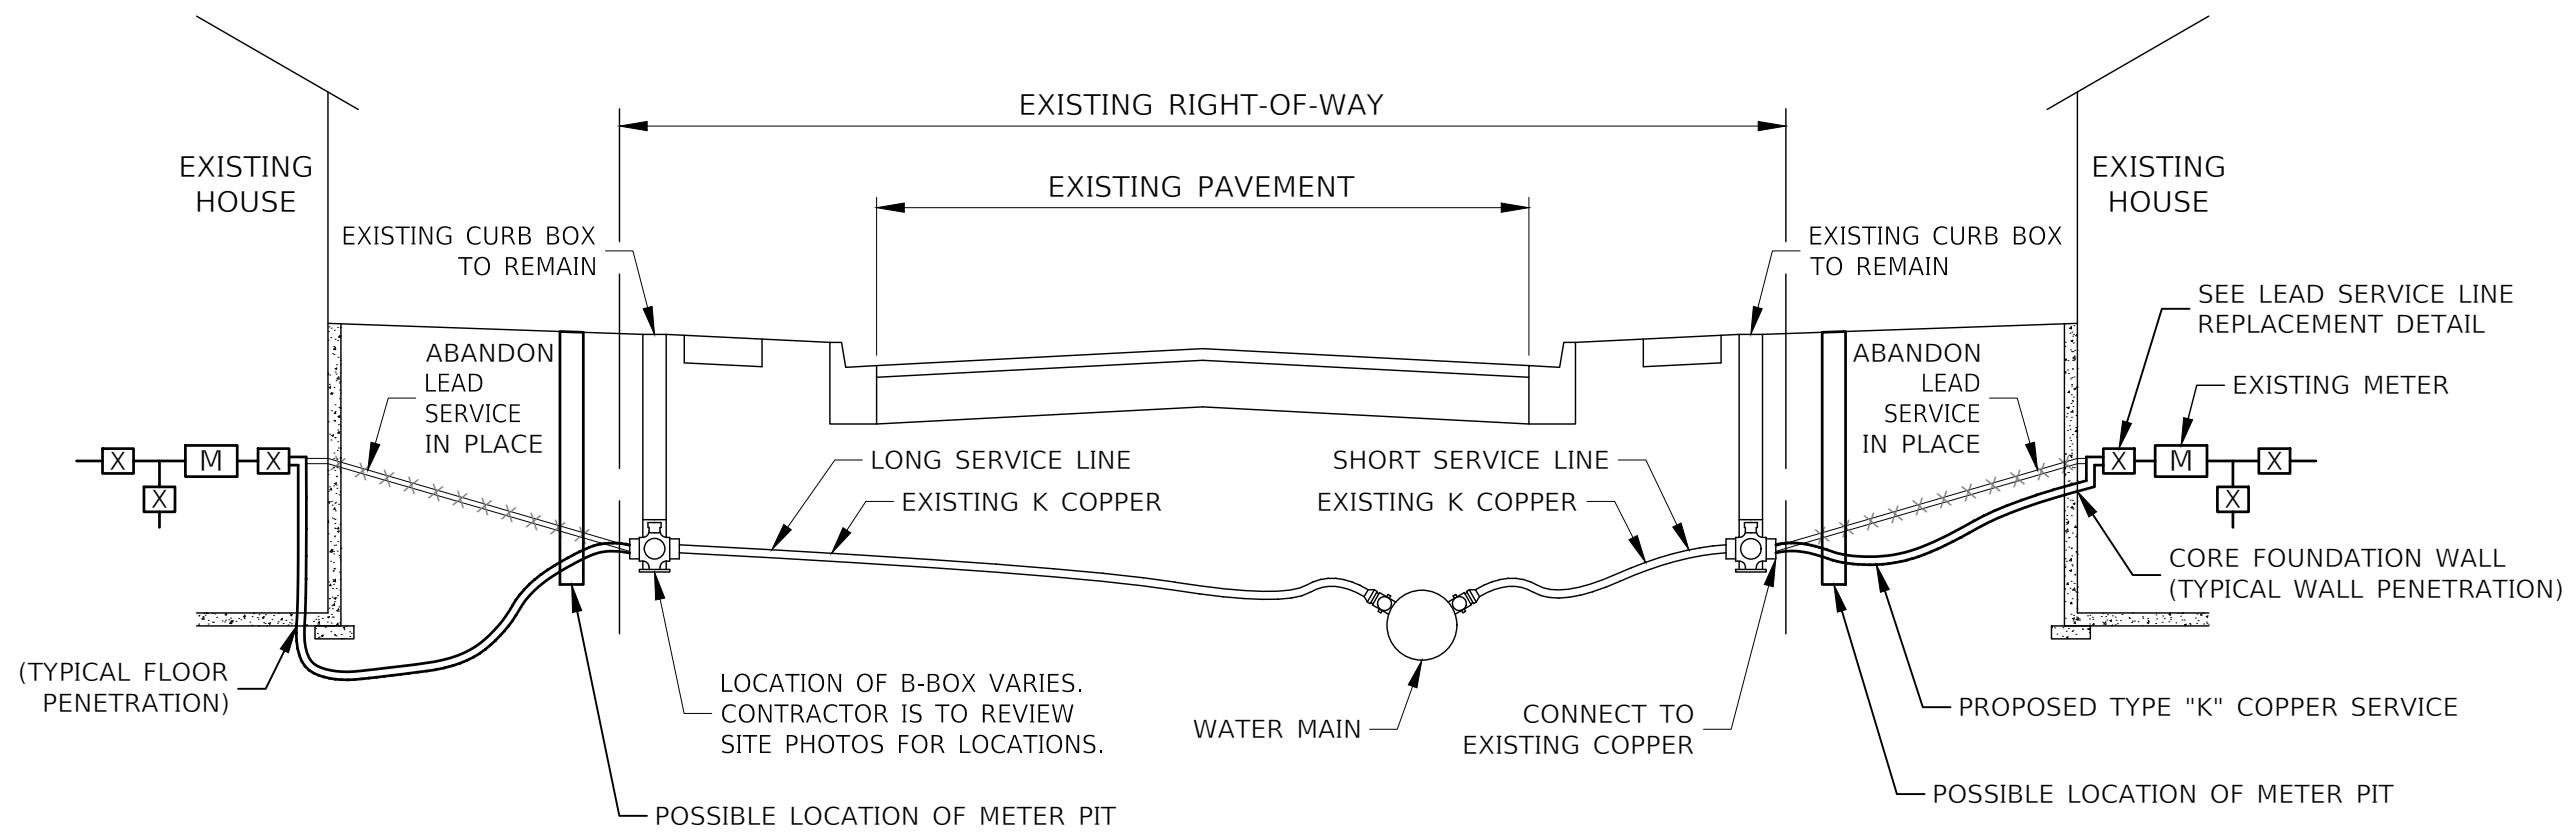
PARTIAL LEAD WATER SERVICE REPLACEMENT PRIVATE SIDE (COPPER)
--	---

- ① ONLY CURB BOXES THAT ARE NOT FUNCTIONING ARE TO BE REPLACED PER THE SPECIAL PROVISIONS. ANY CURB BOXES THAT ARE BURIED SHALL BE ADJUSTED PER THE SPECIAL PROVISIONS.

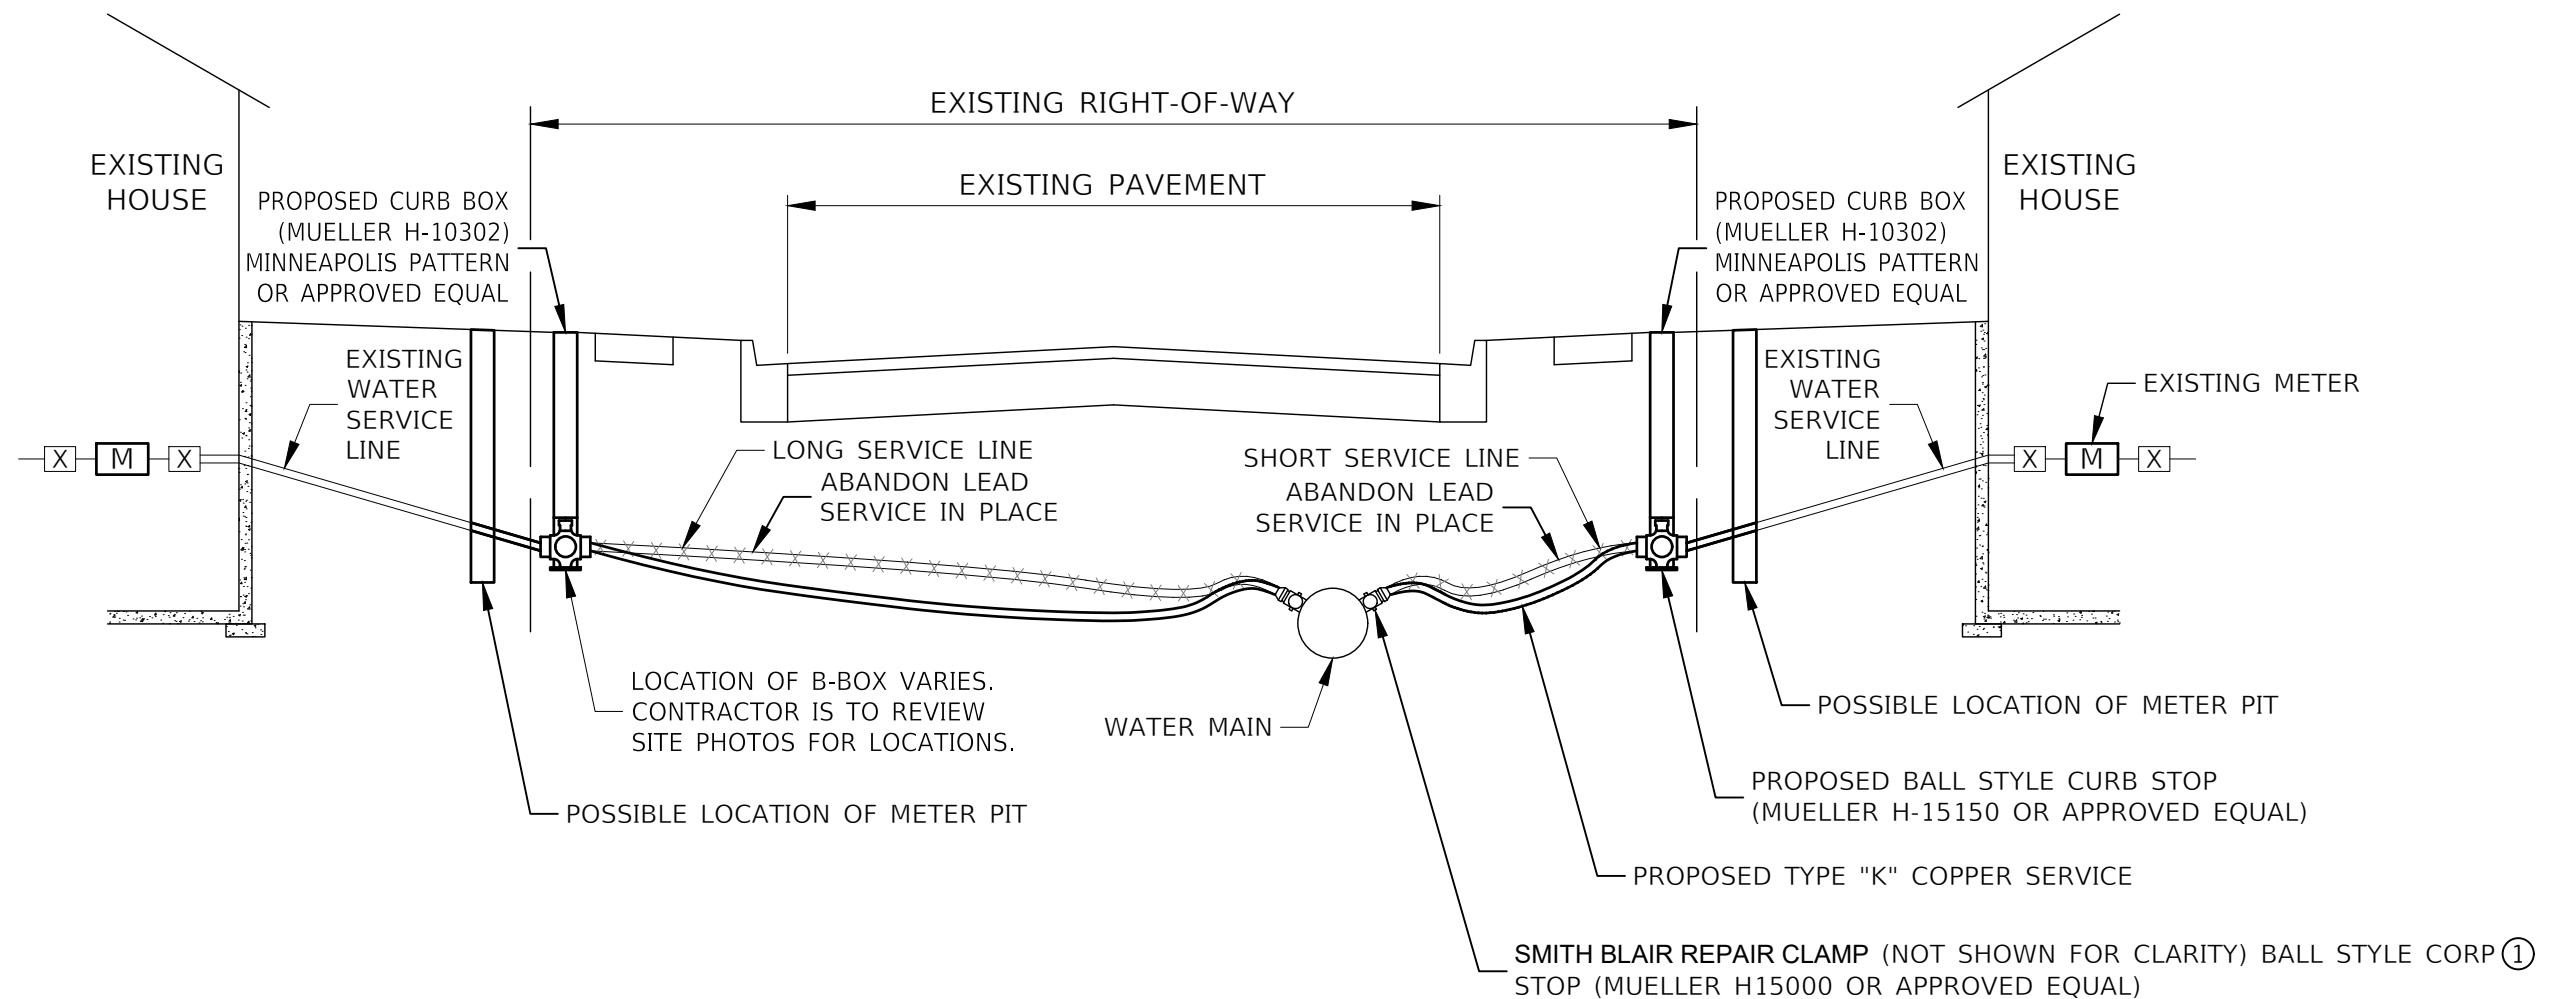
PARTIAL LEAD WATER SERVICE REPLACEMENT
PUBLIC SIDE (COPPER)

NOTE:
① SEE SPECIFICATIONS FOR WATER MAIN TAPPING.
